DETERMINATION OF 3D DISPLACEMENT FIELD IN BEARING AND PULL-THROUGH STRUCTURAL LOADING OF SANDWICH INSERTS

Charles S. Hill

Ovidio Oliveras

Displacement Field in Sandwich Insert Structural Loading

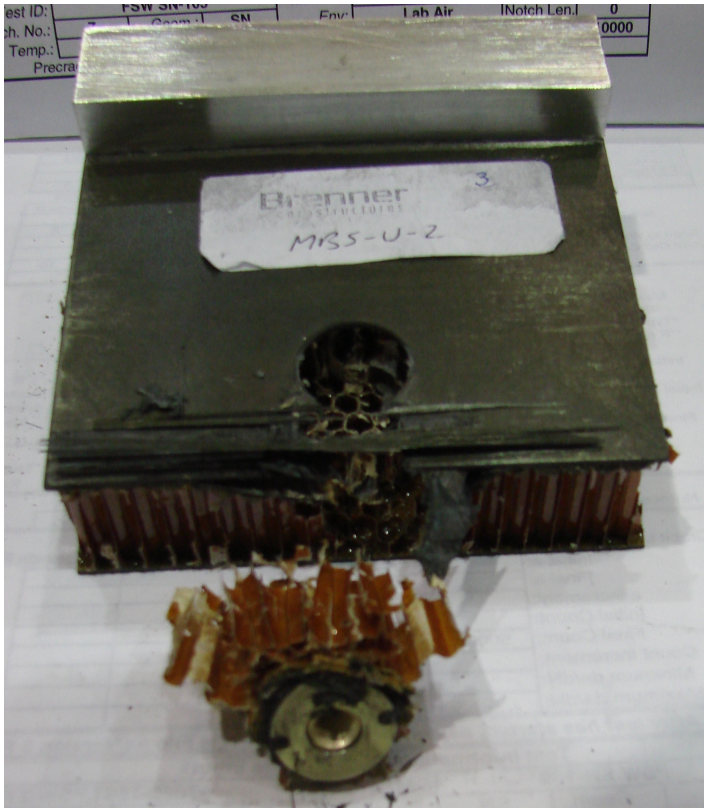
Shear Tear Out (STO) Fixture

Design Development Tests

Development Sandwich Insert Sub-element Bearing Mechanical Property Test

- Experimental
 - Development Tests
 - ~100 individual coupons
 - Range of insert diameters
 - Varied distance to edge to locate effective minimum
 - Bonded Aluminum Bar “tabs” for shear loading
 - Problematic due to alignment precision and peel mode
 - Large insert coupons failed the mounting tabs
 - Small inserts displayed fastener yielding
 - Usable data but not all measurements of insert property
 - Insufficient Fill of Epoxy Potting

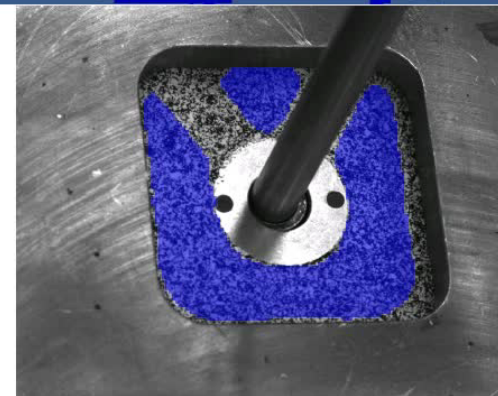
Left Camera with Strain Overlay

X, Y, Z Displacements at Break

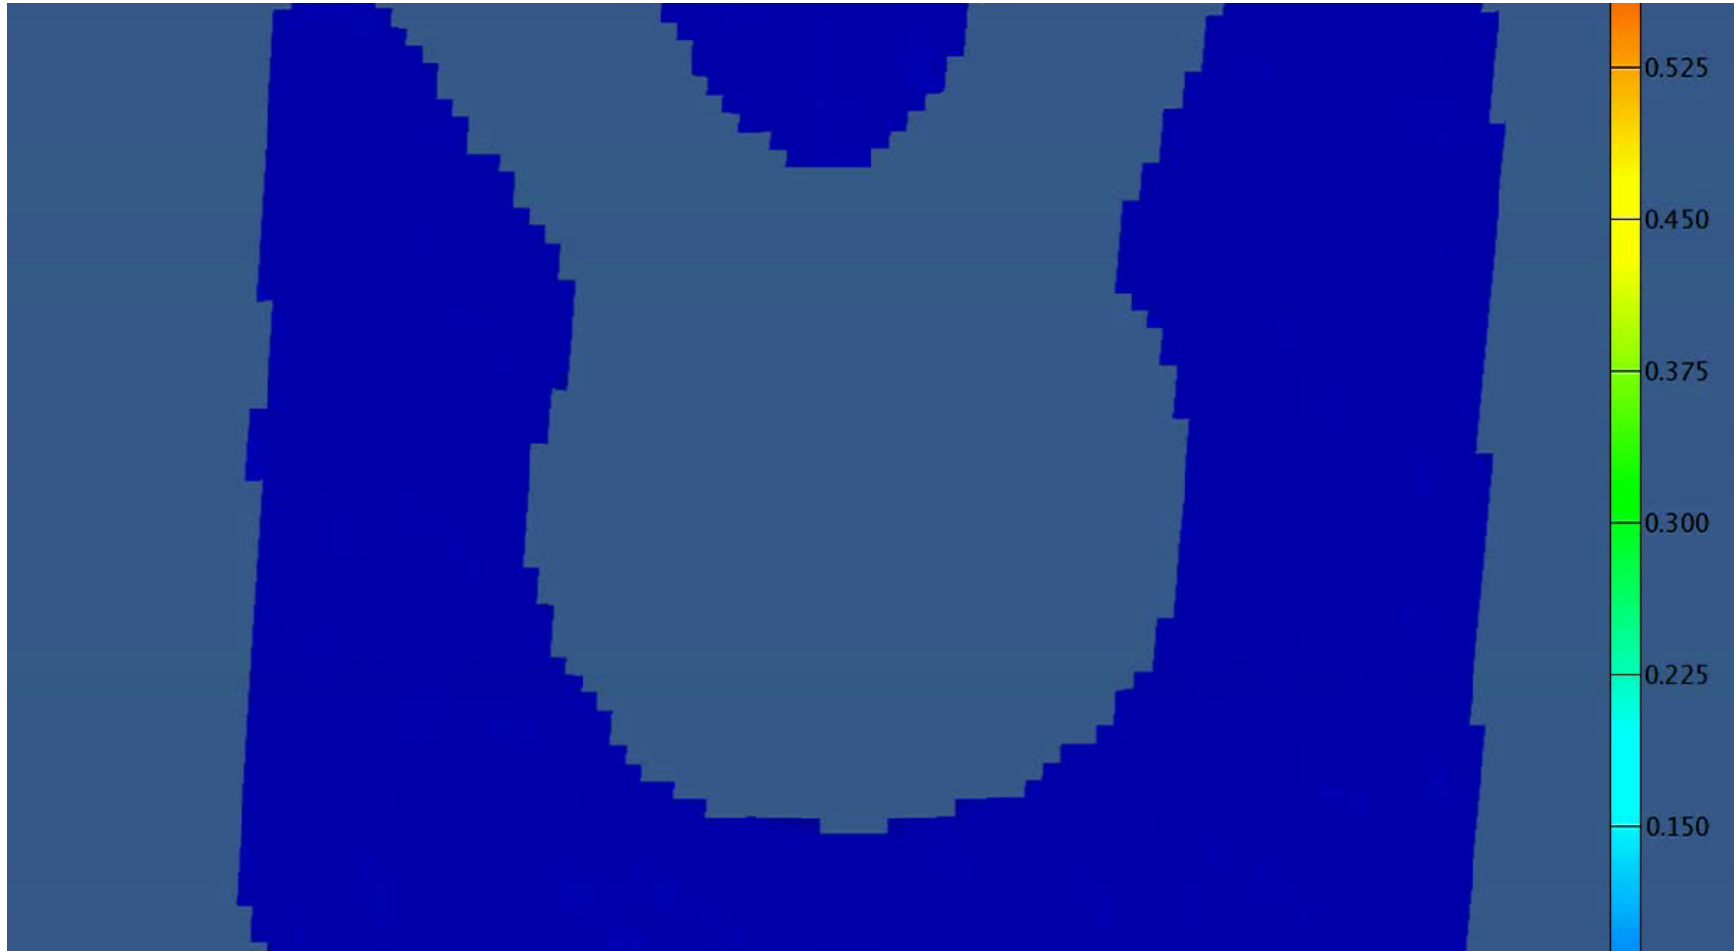
Specimen PO-1835-C3S-01

Major Strain Field and Direction Evolution During Loading Event

- Pull-Through
 - High Strain Areas Evident at Insert Edge
 - Major Strain Direction Develops Tangent to Insert
- Shear Bearing
 - High Strain Primarily at Insert Compressive Edge
 - High Percentage of failure load maintained through tear-out
- 100% Inspection of all critical inserts
 - X-ray Difficult to Quantify Porosity
 - Multiple Views not Possible on Most Parts
- ARAMIS Method Excellent for Test Verification
 - FEA Model Correlation Possible
 - Complex Shapes
 - Identify Locations for Strain Gauge

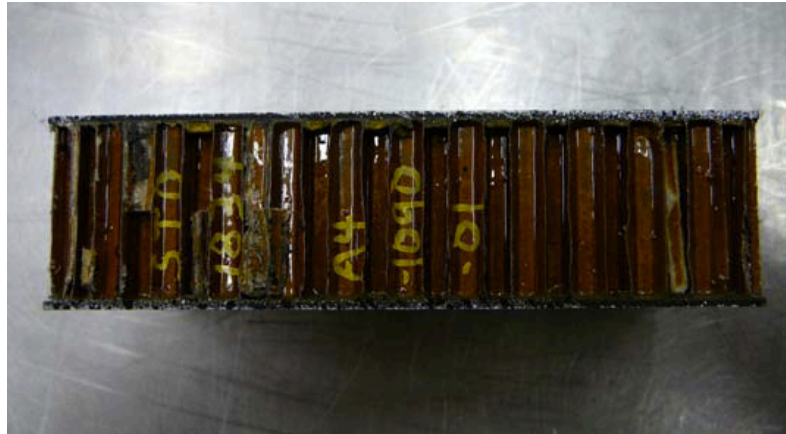
- NAS1834-A5-1090
- 5 specimens with two large through inserts on a composite honeycomb sandwich were use for bearing test.
- Specimen dimensions are 4" x 2" x 1".
- Specimen was spray painted with a white and black speckle pattern.
- All specimens where pulled to failure.

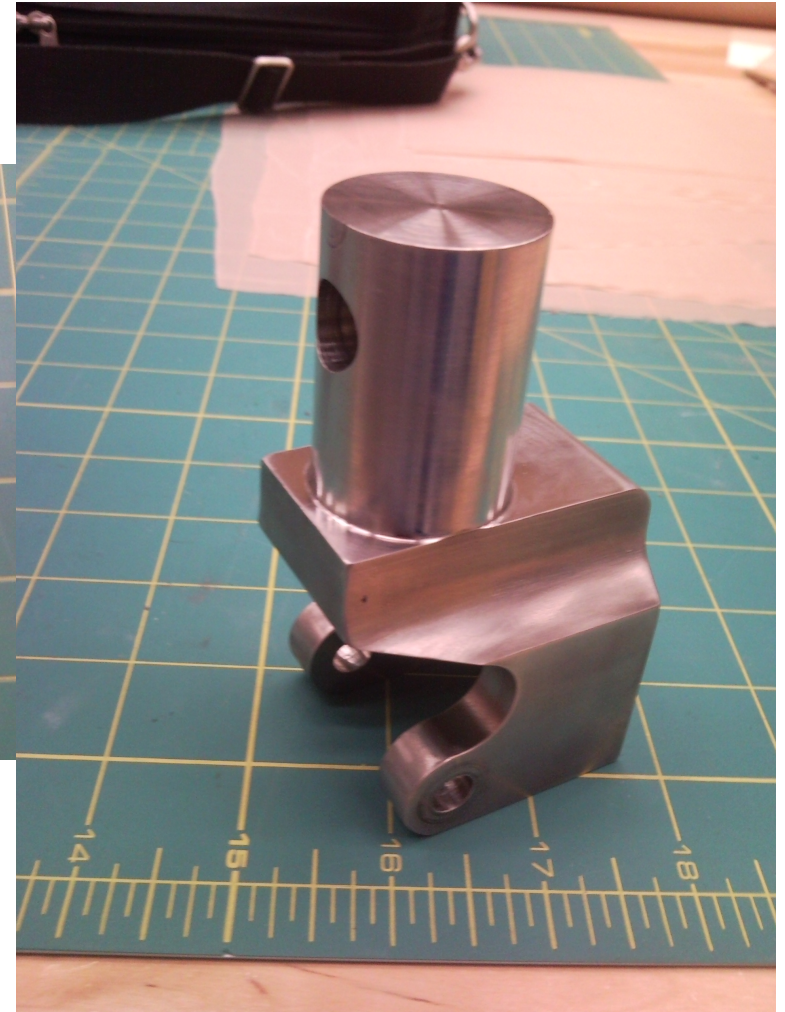
Bearing Fixture Designed for 180° View of Insert Edge
